ΓΕΝΙΚΟ ΝΟΣΟΚΟΜΕΙΟ ΑΘΗΝΩΝ
Ο ΕΥΑΓΓΕΛΙΣΜΟΣ

Lead perforation – A case report

Γεώργιος Μπαζούκης
Ειδ/νος καρδιολογίας
ΓΝΑ «Ο Ευαγγελισμός»

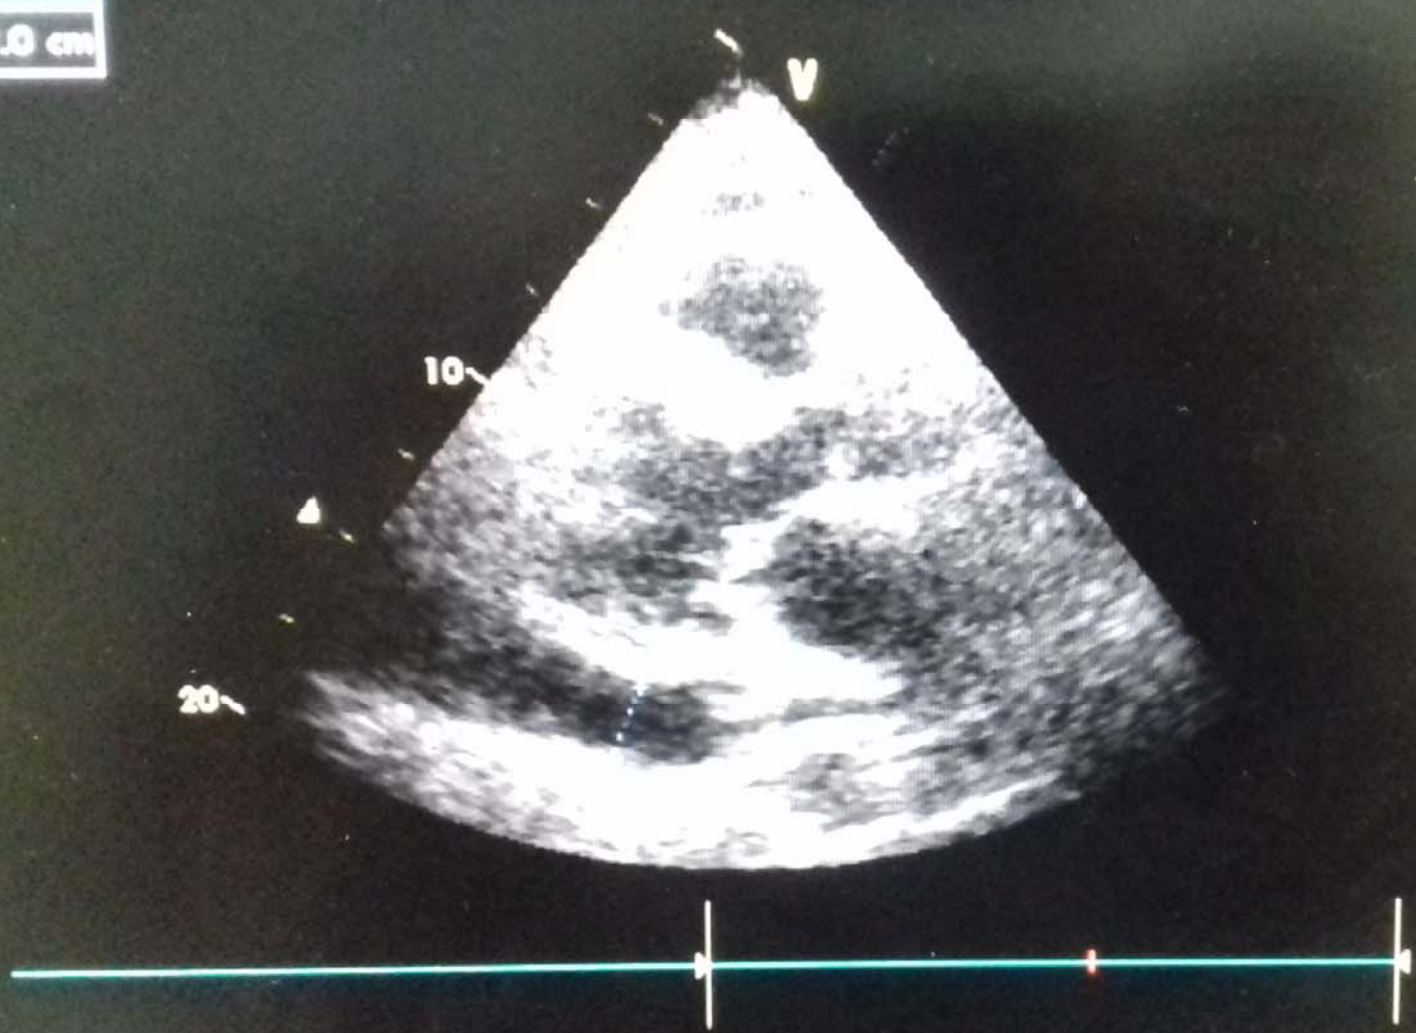
Subsequent echocardiographic evaluations showed a progressive increase in pericardial effusion (3,2cm) without tamponade physiology findings

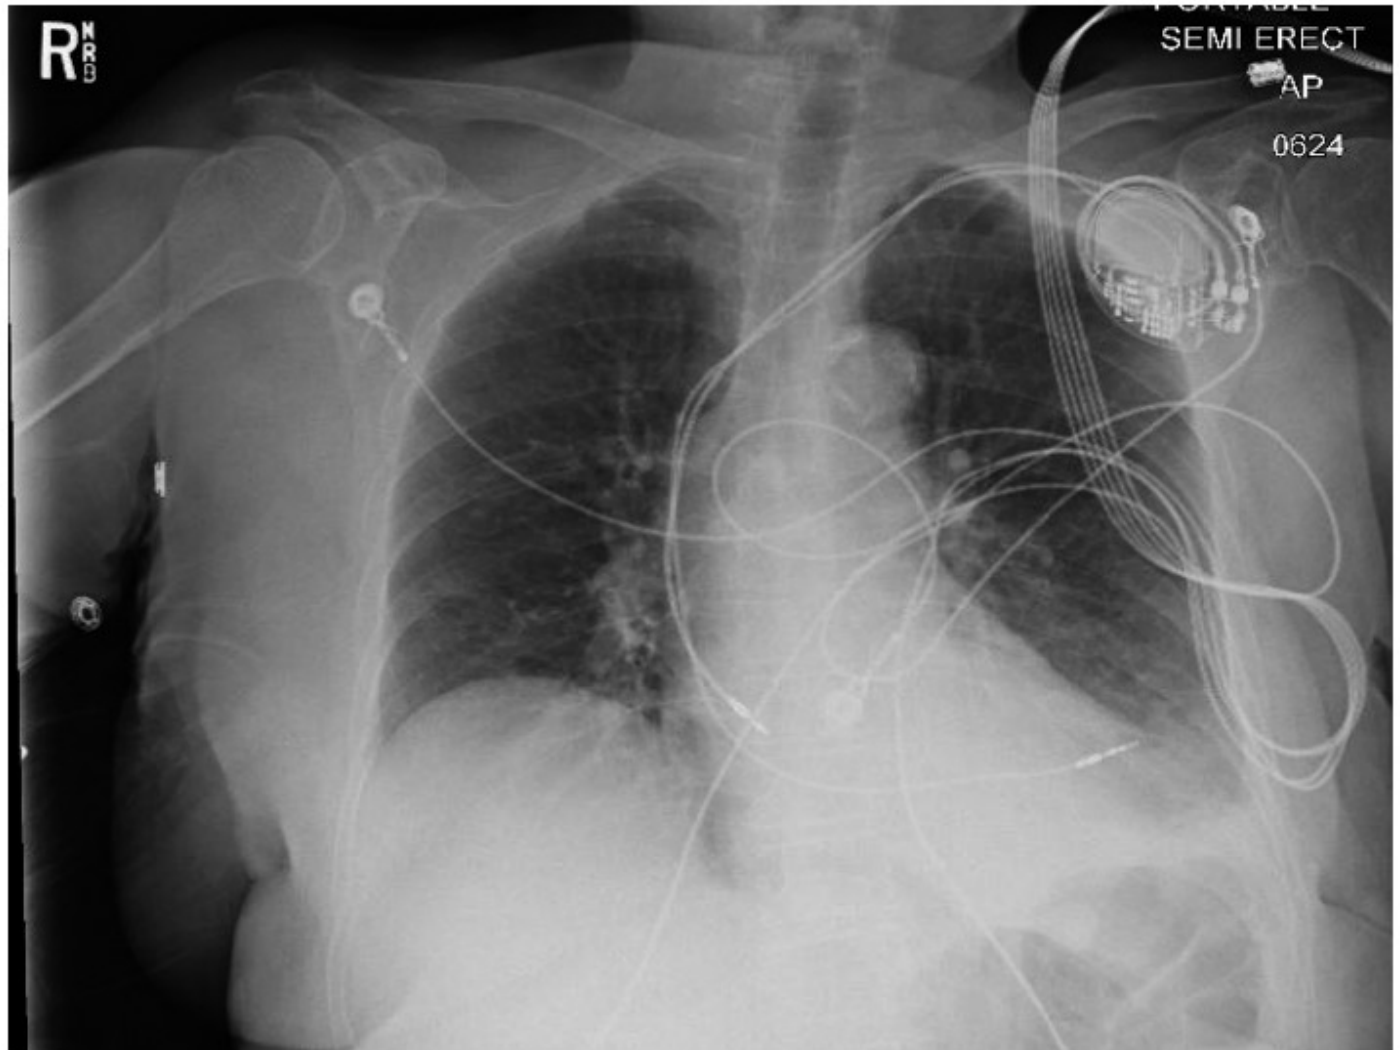
Diagnosis – x-ray

A chest X-ray of the patient on presentation revealing the right ventricular lead overlying the left.

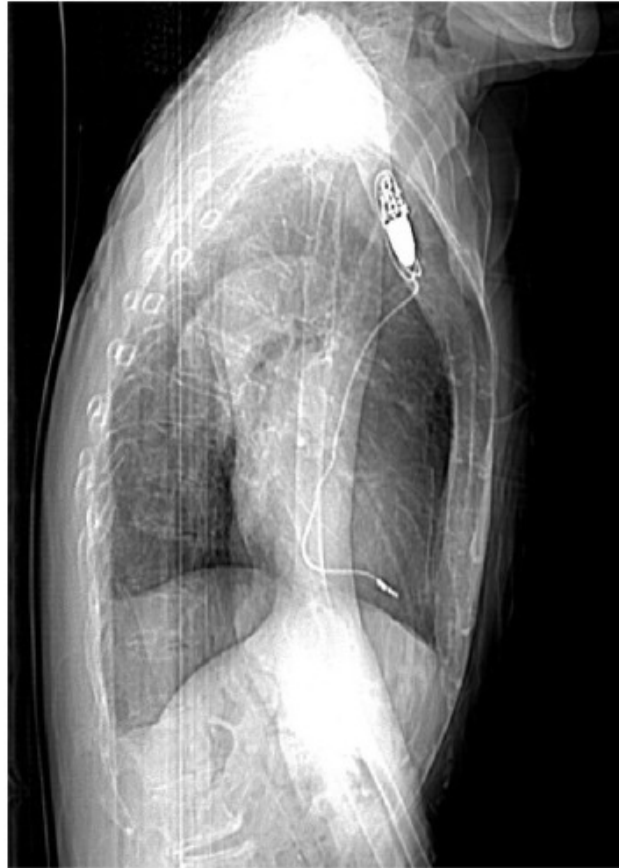
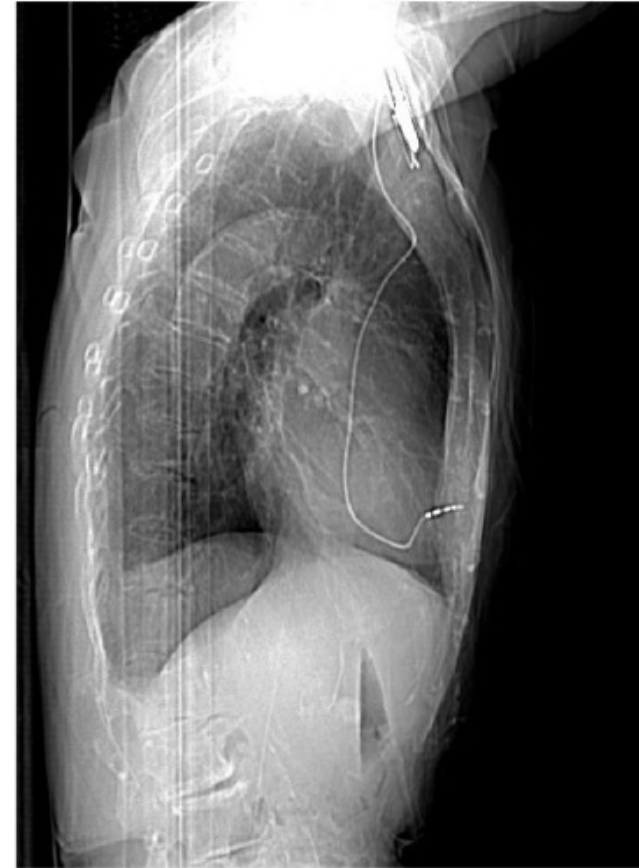
Diagnosis – x-ray

Lateral chest X-ray film demonstrating the position of the lead. (a) Just after the surgery. The tip of the lead was in the correct position. (b) Four days after the surgery. The tip of the lead intruded into the chest wall.

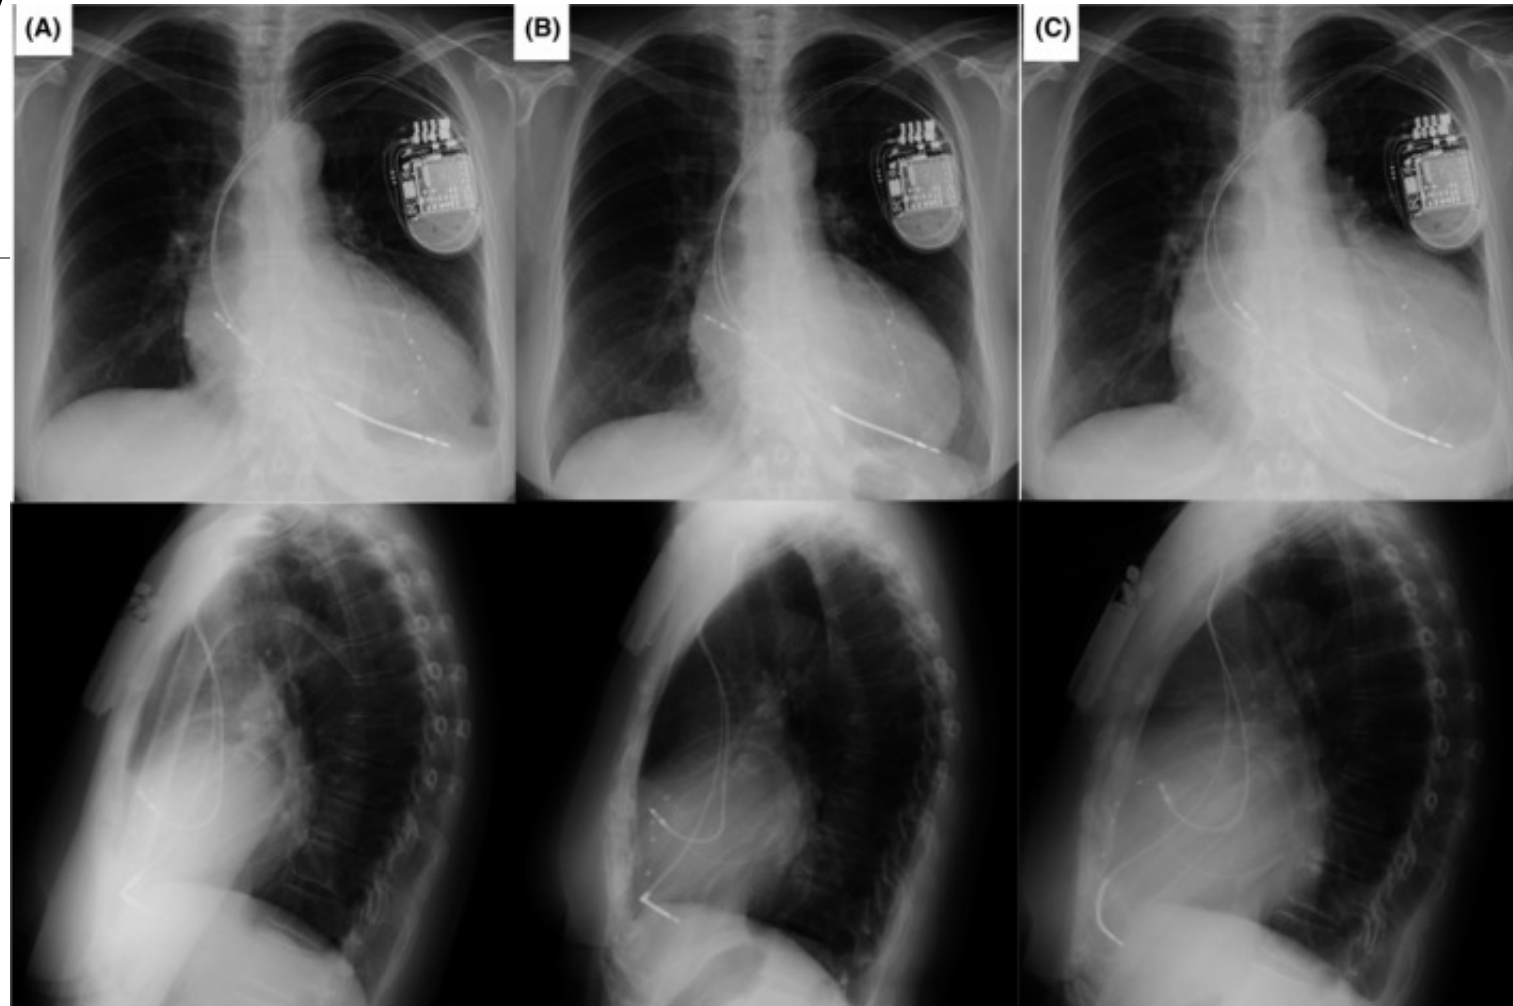
Diagnosis – x-ray

Serial posterior–anterior (upper row) and left lateral chest (bottom row) X-ray films showing the ICD lead position. (A) Films obtained at the time of the patient's initial discharge. (B) Films obtained at the time of the first outpatient visit after implantation. (C) Films obtained at the time of re-admission. At this time, the cardiothoracic ratio had clearly increased.

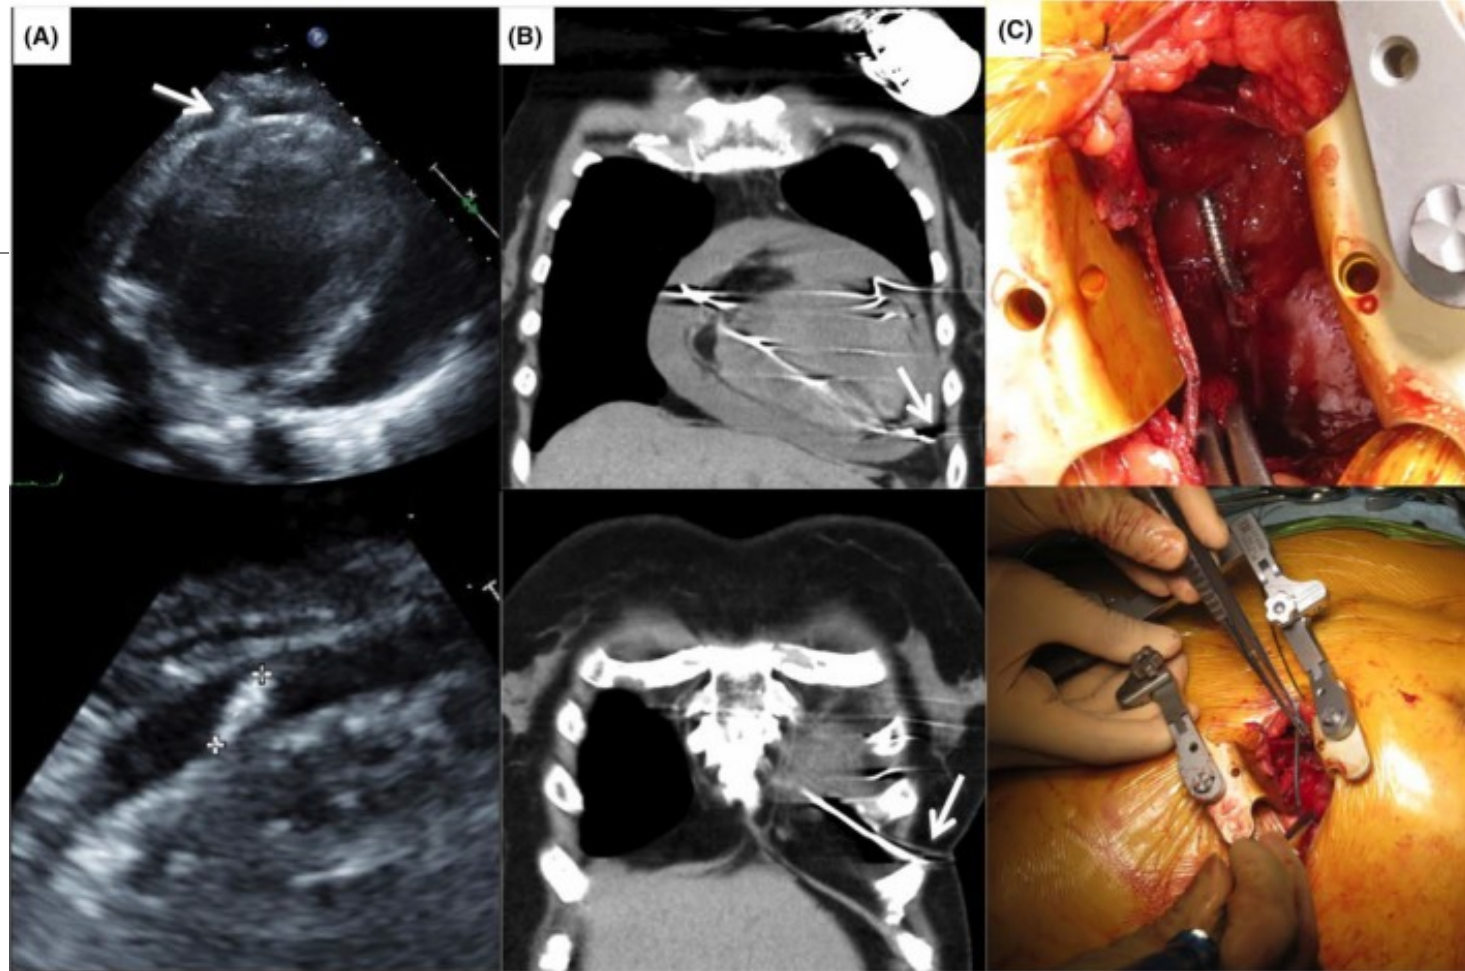
Diagnosis – ECHO

Investigation and confirmation of the cause of the patient's sudden complaints. (A) Echocardiogram showing severe pericardial effusion and the ICD lead (white arrow) extending beyond the ventricular apex. (B) Chest computed tomography image showing that the tip of the ICD lead (white arrow) had perforated the right ventricular wall and migrated beyond the epicardium. (C) Intraoperative photograph. Visual inspection confirmed that the ICD lead had perforated the right ventricular wall.

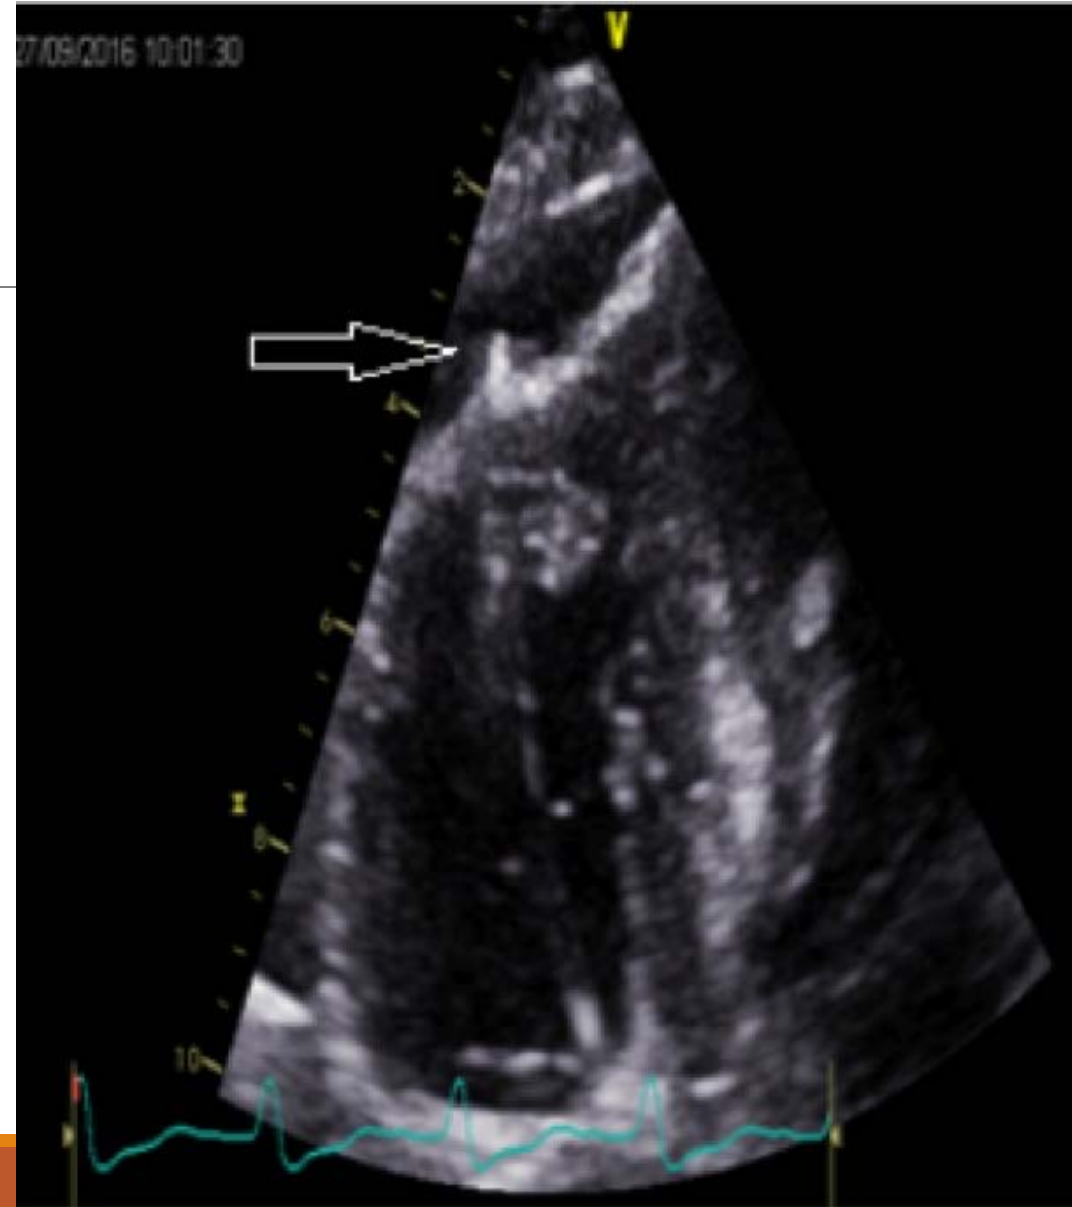
Diagnosis - ECHO

Zoom of right ventricle in the apical four-chamber view: lead tip visualized in the pericardial space, confirming perforation (arrow).

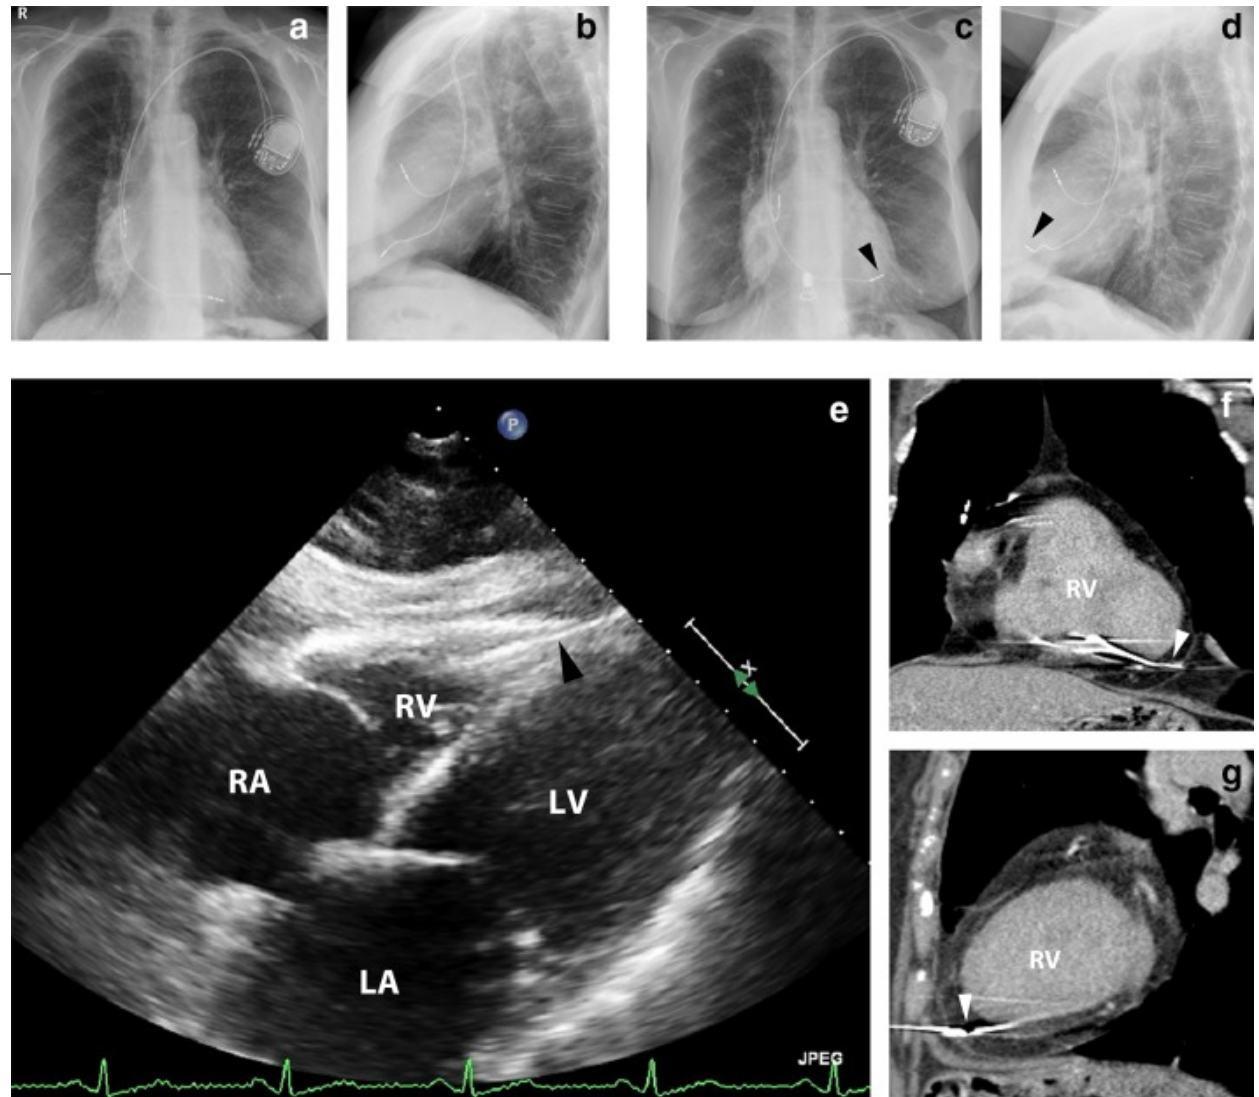
Diagnosis - ECHO

a Chest radiography [postero-anterior (PA) view] the day after pacemaker implantation. **b** Lateral view. **c** Chest radiography (PA view) upon presentation to the emergency room showing an altered position of the RV lead (*arrowhead*). **d** Lateral view (*arrowhead* shows altered lead position). **e** Transthoracic echocardiography (subcostal view) suggesting myocardial perforation of the RV lead through the RV apex (*arrowhead*), but without pericardial effusion, raising doubt as to whether the lead tip lay in the pericardial space. See also online video. *LA* left atrium, *LV* left ventricle, *RA* right atrium, *RV* right ventricle. **f** Thoracic computed tomography (coronal view) with lead tip clearly visible through the myocardium (*arrowhead*). *RV* right ventricle. **g** Thoracic computed tomography (sagittal view) showing lead tip running through myocardium (*arrowhead*). *RV* right ventricle

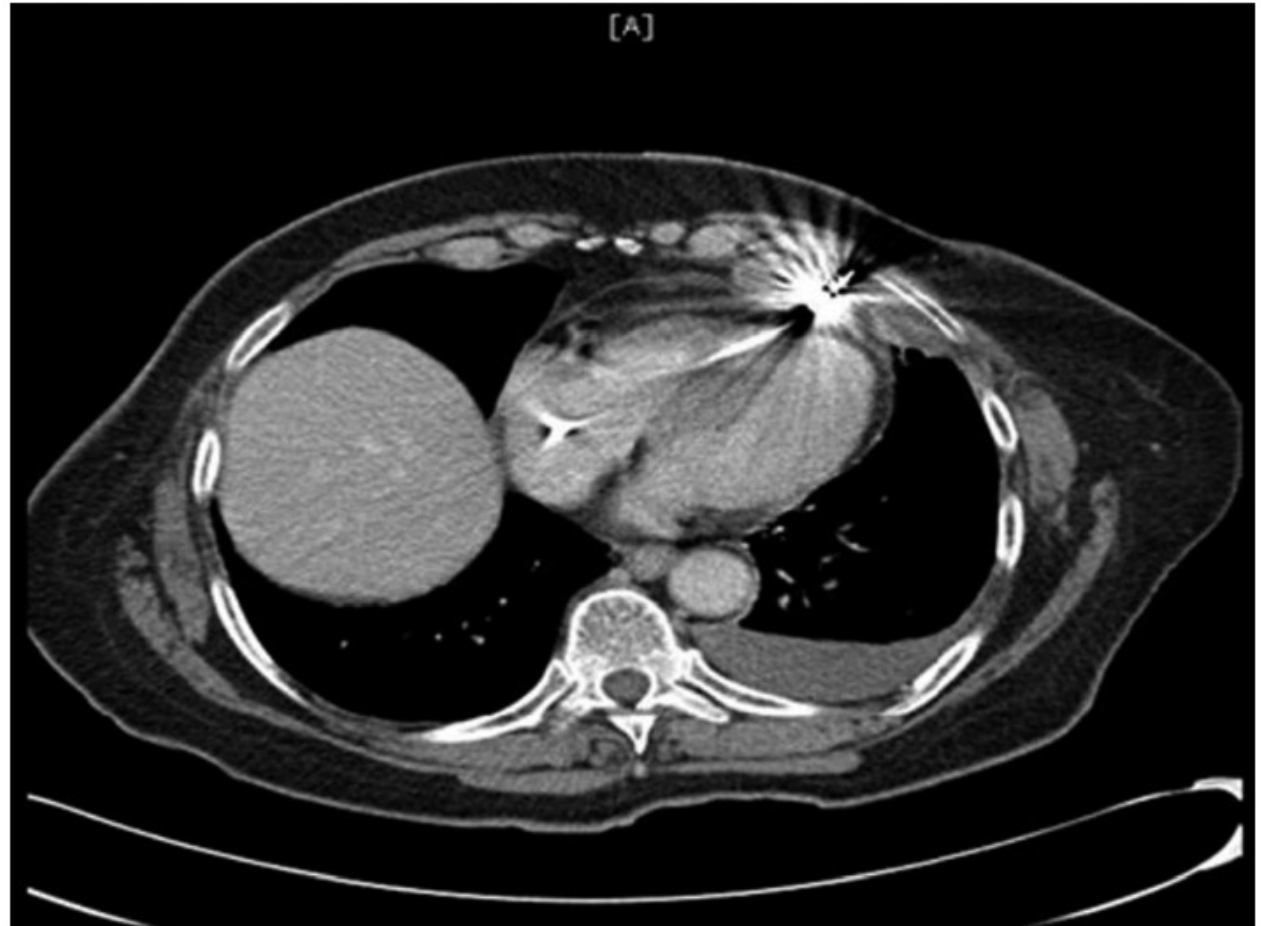
Diagnosis – CT scan

CT scan showing the tip of the right ventricular lead penetrating the anterior wall of the right.

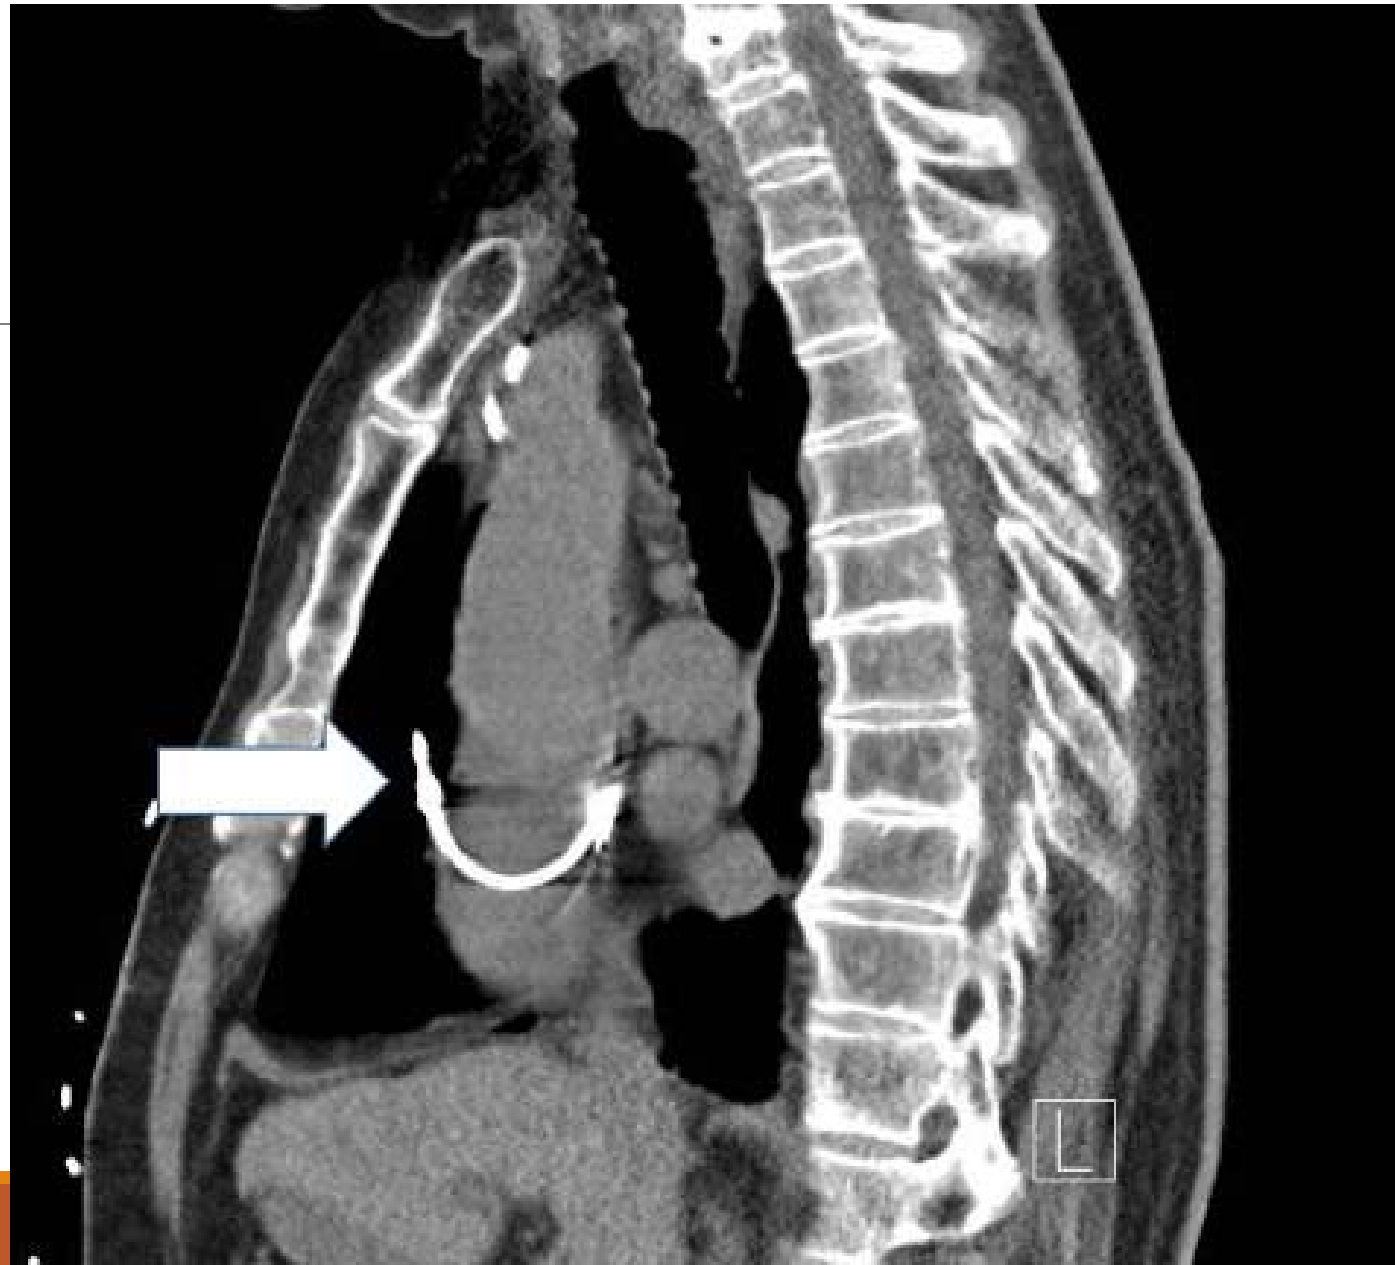
High-resolution computed tomography scan of the chest sagittal cut with the white arrow pointing at the tip of the atrial lead migrating into the right lung

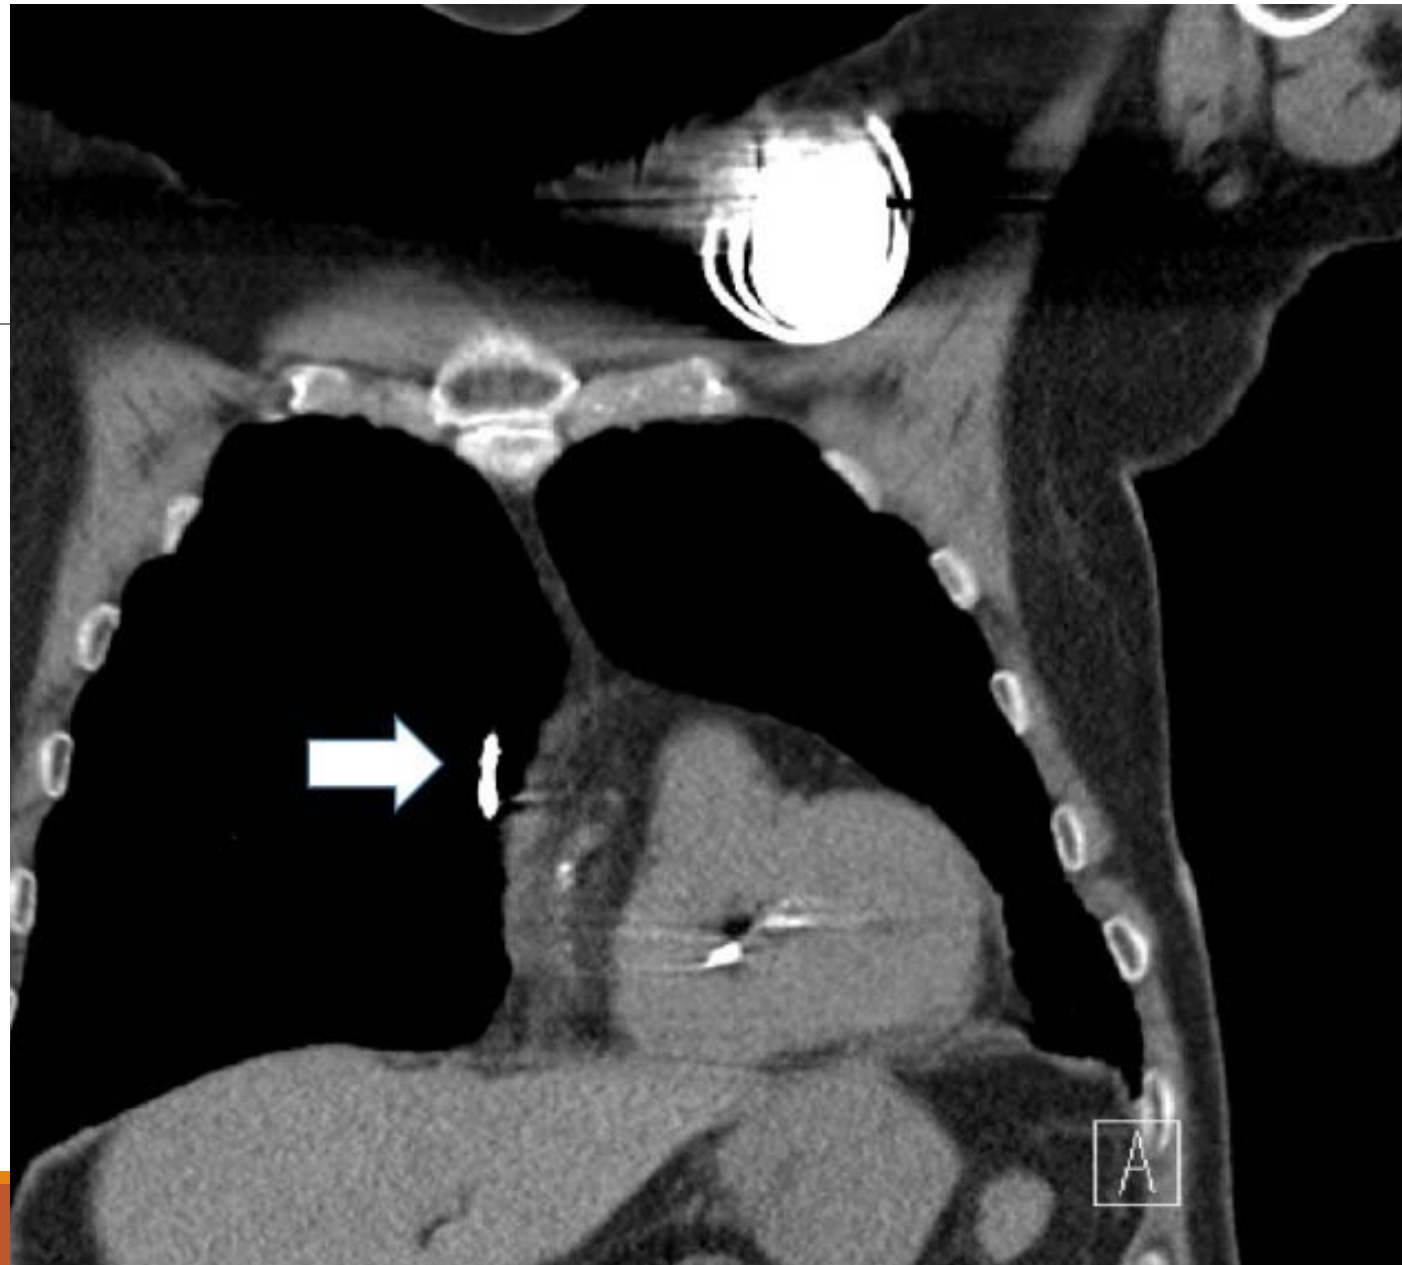
High-resolution computed tomography scan of the chest sagittal cut with the white arrow pointing at the tip of the atrial lead migrating into the right lung

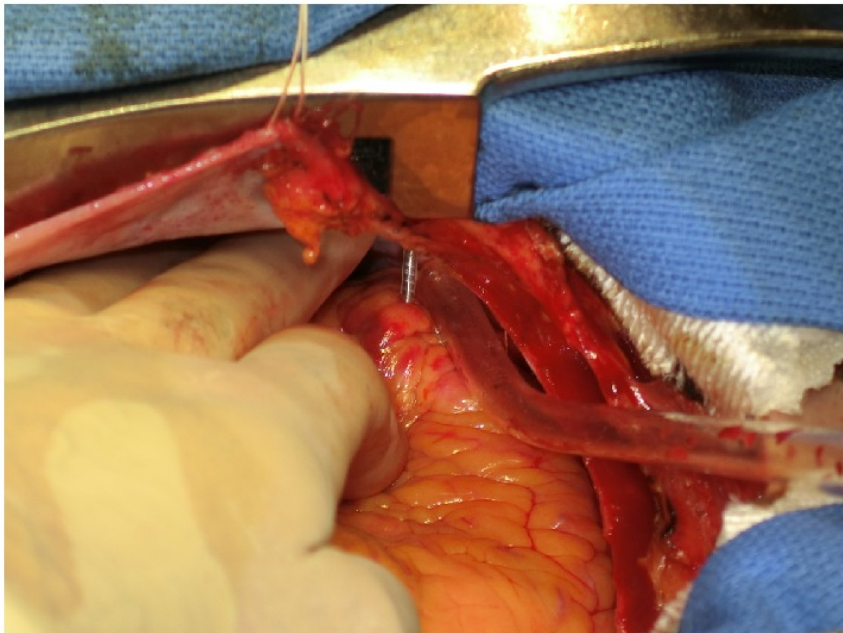
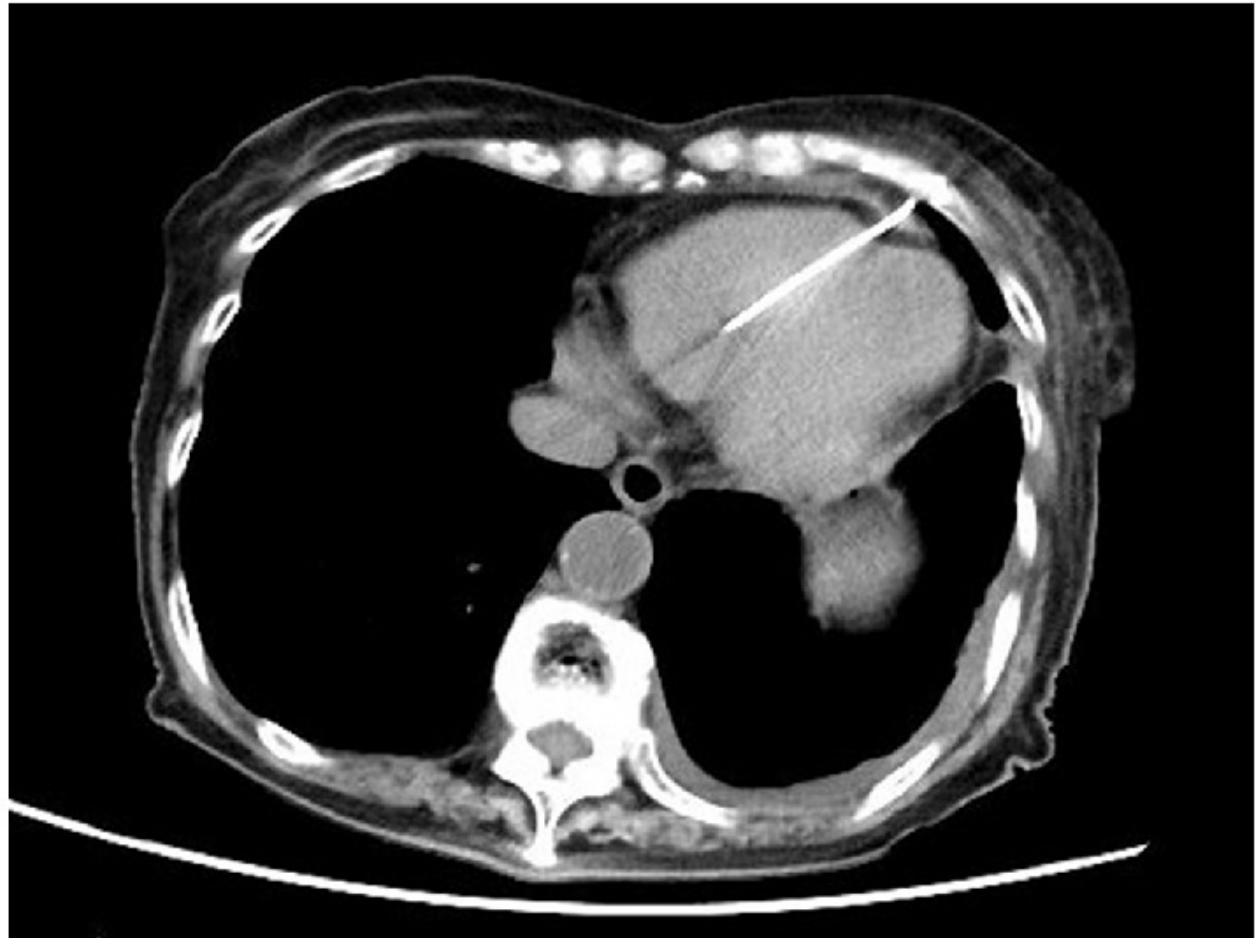
Chest CT reveals
perforation of the right
ventricle by the lead.

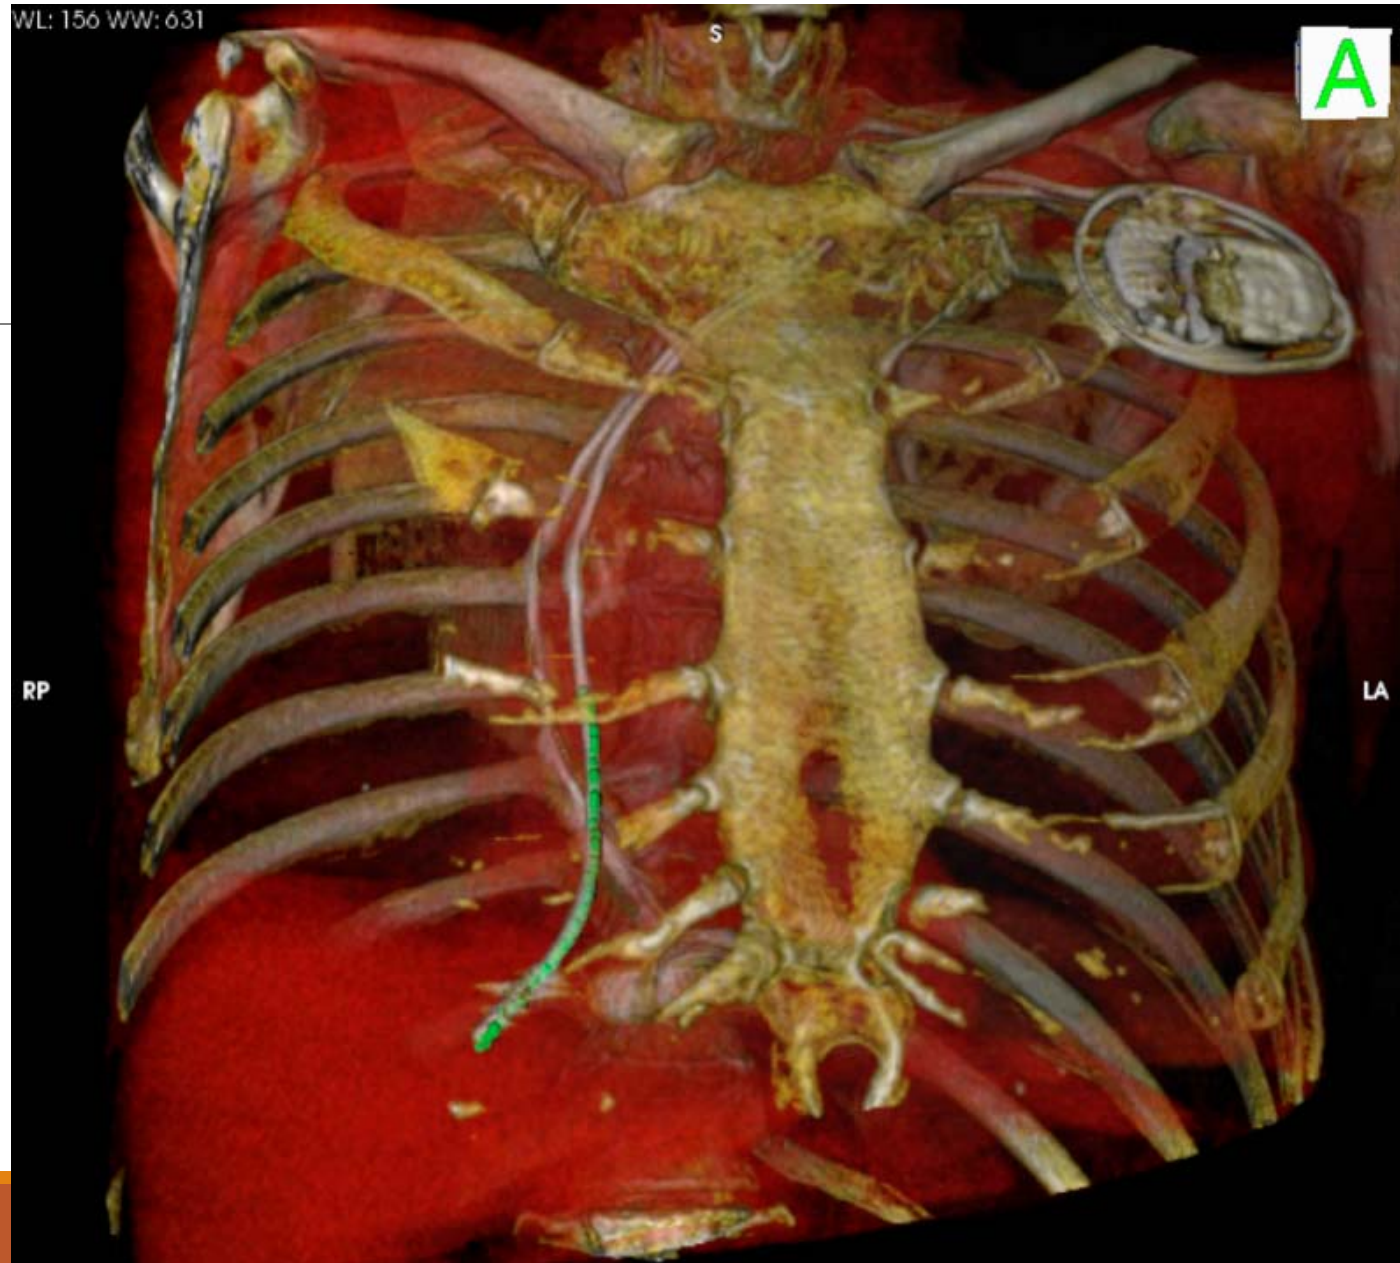
Computed tomographic 3-dimensional reconstruction scan showing the atrial lead migration into the right pleural cavity. LA = left anterior; RP = right posterior.

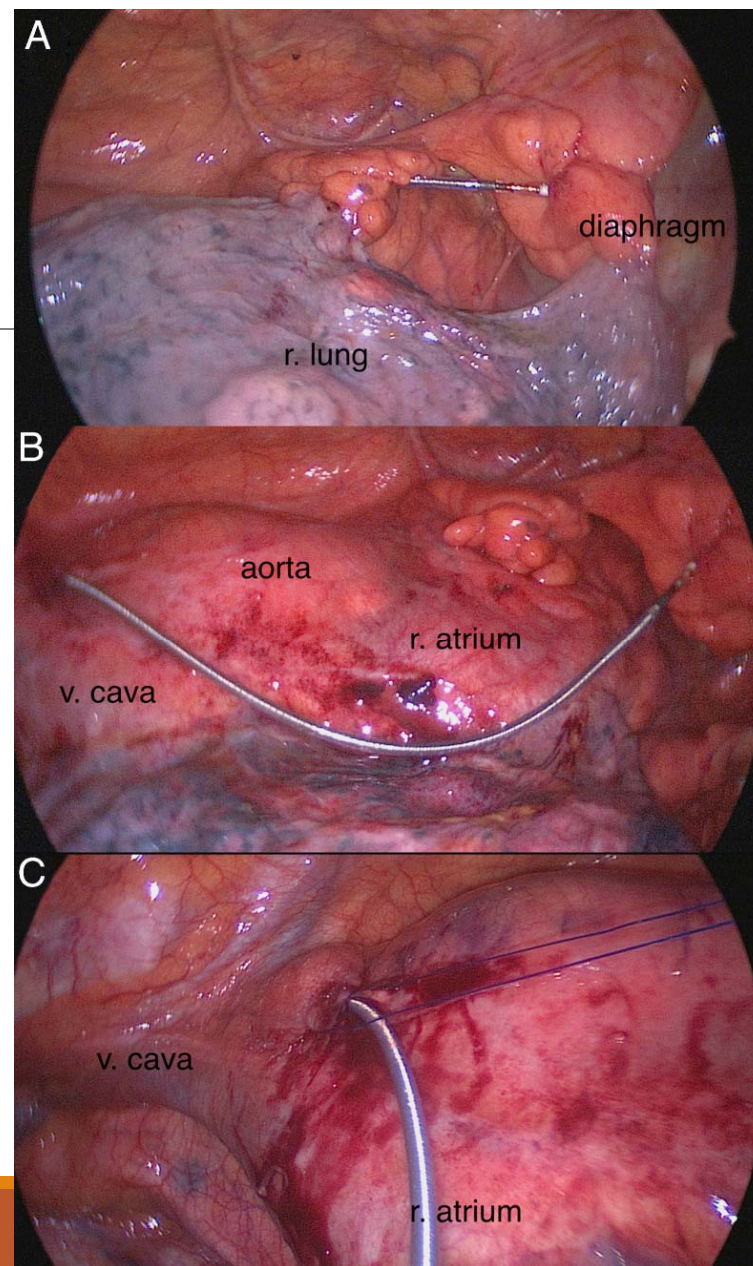
Intraoperative photographs.

A, B: Perforation of the extrapericardial part of the superior vena cava with pacemaker lead migration into the right pleural cavity. **C:** The suture placed around the vena cava perforation.

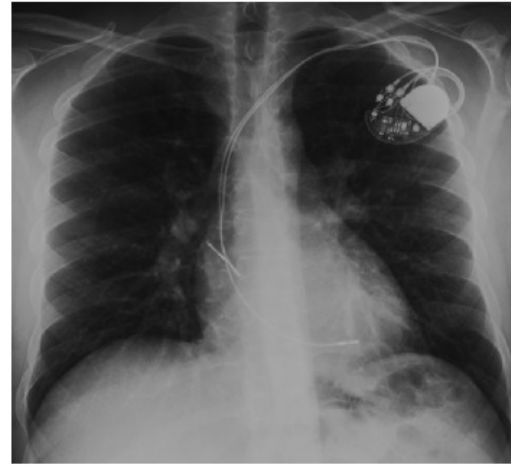
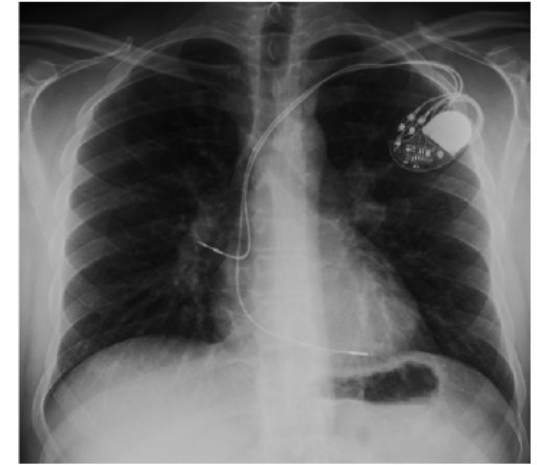
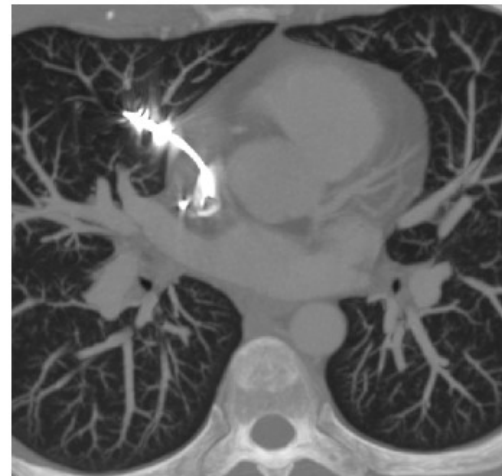
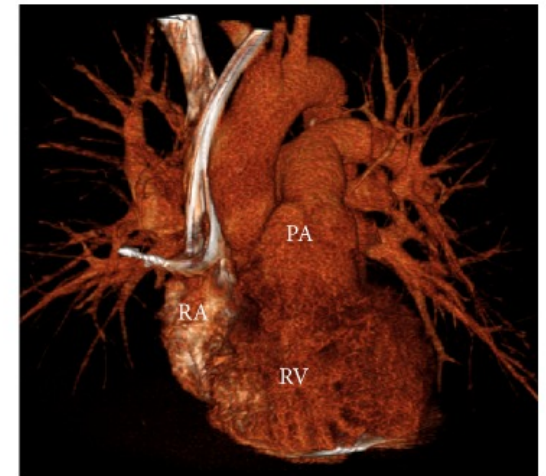
Atrial lead perforation

(a) Postimplant anteroposterior chest radiography showing the atrial lead positioned at the basal part of the right atrial appendage. (b) Anteroposterior chest radiography performed at 8 months showing a clear late migration of the atrial lead into the right lung. (c) Contrast-enhanced CT-scanner with maximal intensity projection (MIP) and (d) volume rendered reformatting (anterior view) demonstrating the migration of the atrial lead into the right lung. Notably the pericardium, pleura, and pulmonary parenchyma were normal. RA: right atrium; RV: right ventricle; PA: pulmonary artery.

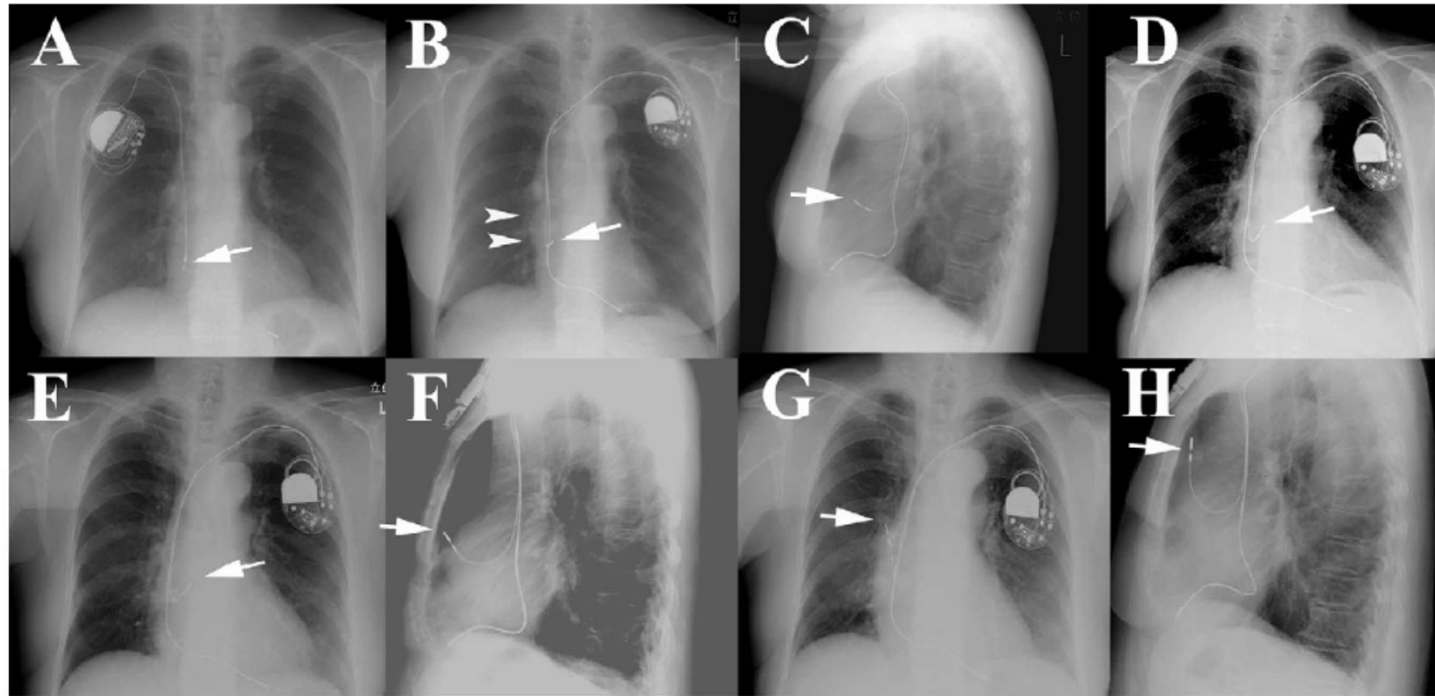
Progressive Atrial lead perforation

Figure 1 Chest X-rays. Compared to the image before the replacement of pacemaker (A), the image 1 week after the replacement (B) showed only a focal protrusion from the right side of cardiac silhouette (arrowheads) and the lateral image (C) did not show any abnormalities. The image 2 years later had no serial change (D), however 3 years and 9 months later, a lateral view (F) clearly showed atrial lead protrusion, while the lead changed to be tip-tilted on the frontal view (E). One year later, both of frontal (G) and lateral views (H) demonstrated the progression of atrial lead protrusion. The arrows indicate the distal tip of atrial lead.

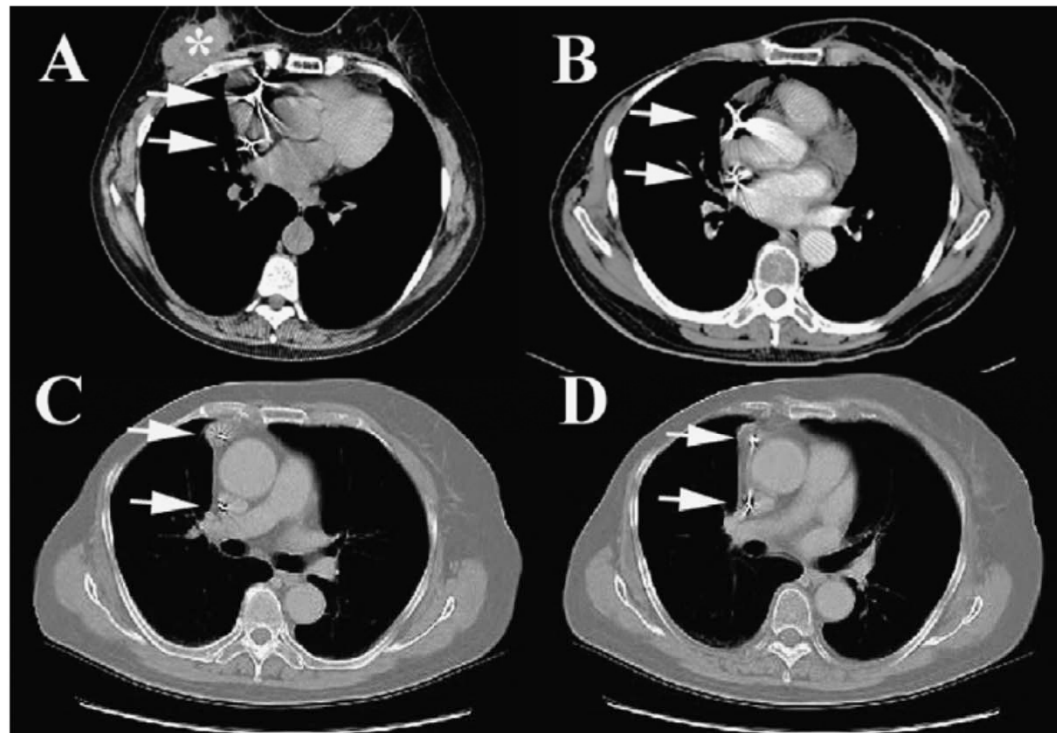
Progressive Atrial lead perforation

Figure 2 Computed tomography. (A) Before the replacement of the pacemaker, the scan showed right breast cancer (asterisk) and an atrial lead (arrows). (B) Nine months after the replacement, a new atrial lead (arrows) was screwed in almost the same position compared to the previous one and had perforated the right atrial appendage. (C, D) Four years later, the consecutive scans clearly showed the progression of the perforated atrial lead (arrows).
