ΓΕΝΙΚΟ ΝΟΣΟΚΟΜΕΙΟ ΑΘΗΝΩΝ
Ο ΕΥΑΓΓΕΛΙΣΜΟΣ

Lead perforation – A case report

Γεώργιος Μπαζούκης
Ειδ/νος καρδιολογίας
ΓΝΑ «Ο Ευαγγελισμός»

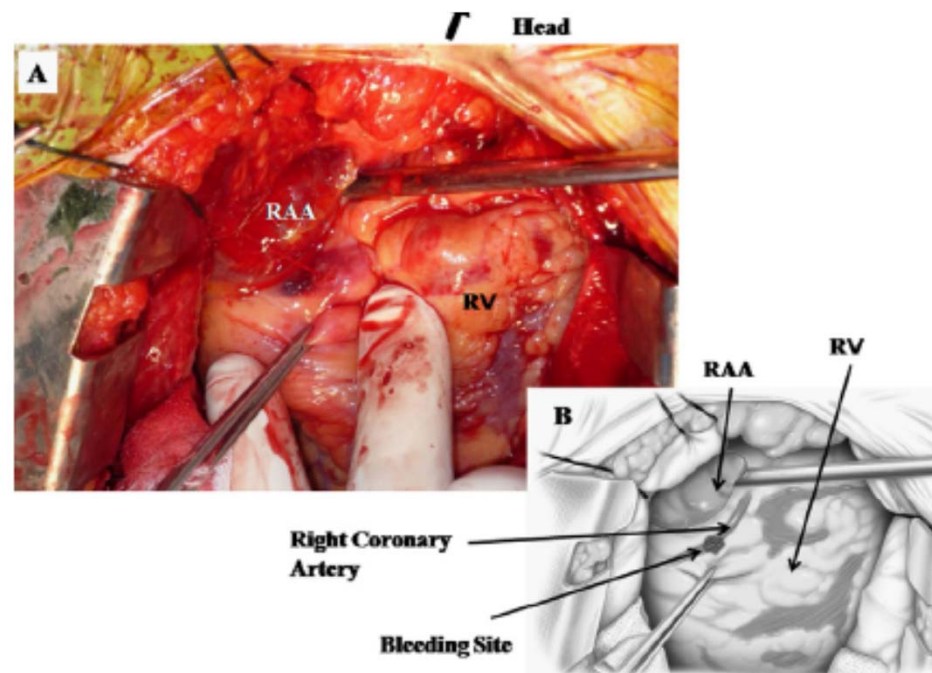
Fig. 2. (A) Intraoperative image of bleeding from the right coronary artery. After evacuation of 1400 mL of hemopericardium along with several thrombi, we determined that bright red blood was gushing out from the right coronary artery, which was located on the opposite side of the right atrial appendage to the atrial lead screw. (B) Intraoperative drawing corresponding to (A). Bleeding site and right coronary artery are drawn illustrated. RV, right ventricle; RAA, right atrial appendage.

Operating room → evacuation 1400 ml hemopericardium with thrombi while bright red blood was seen gushing out from the right coronary artery

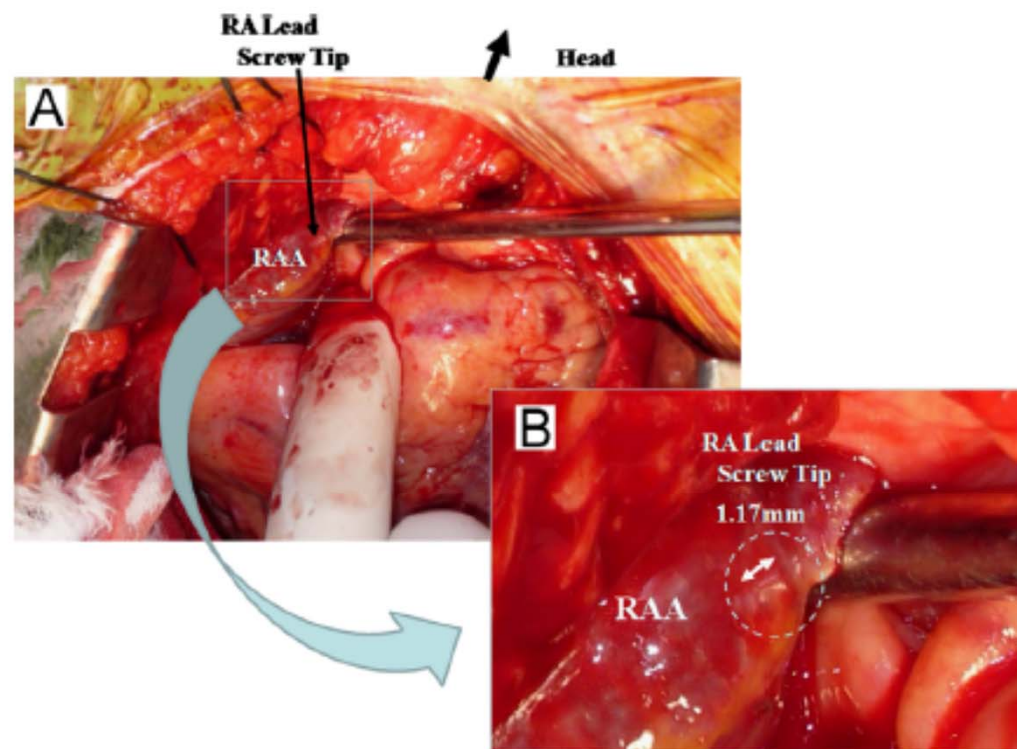
Fig. 3. (A) Intraoperative image showing the atrial lead screw penetrating the right atrial appendage, which was located on the opposite side from the bleeding site. There was no bleeding from the screw tip penetration site. (B) The magnification of (A) is shown. A semi-circular portion of the screw penetrated the atrial wall. The diameter of the screw was 1.17 mm. RAA, right atrial appendage; RA right atrium.

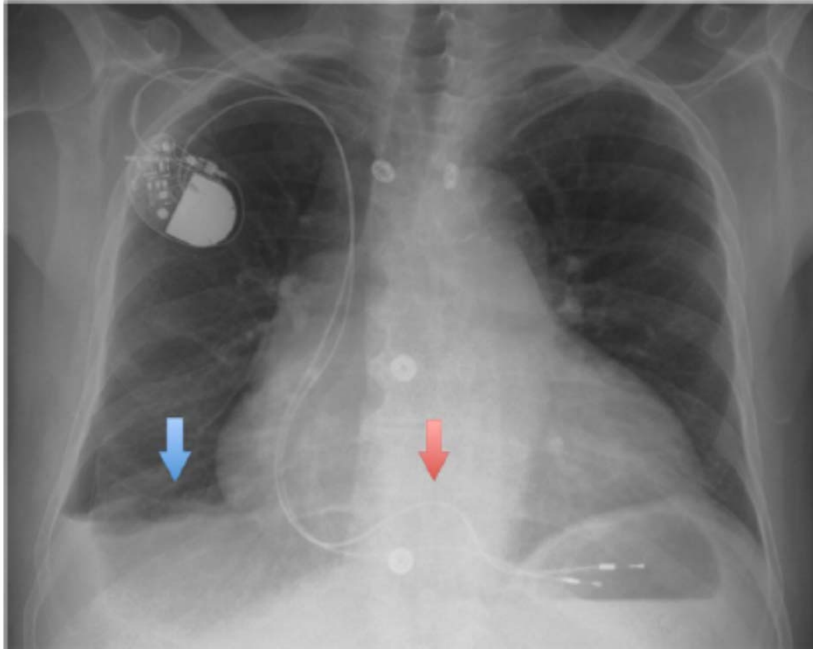
Figure 1 Preoperative chest X-ray. Blue arrow: pleural effusion; Red arrow: different course of the two leads through the tricuspid valve.

Four years earlier he had received a VVIR pacemaker with a passive lead (Refino 58 ER, Oscor; Palm Harbor, FL, USA) due to atrial fibrillation with atrioventricular conduction block. Three years later, another passively fixed ventricular lead had been placed due to a failure of the original pacemaker lead resulting in increasing impedance.

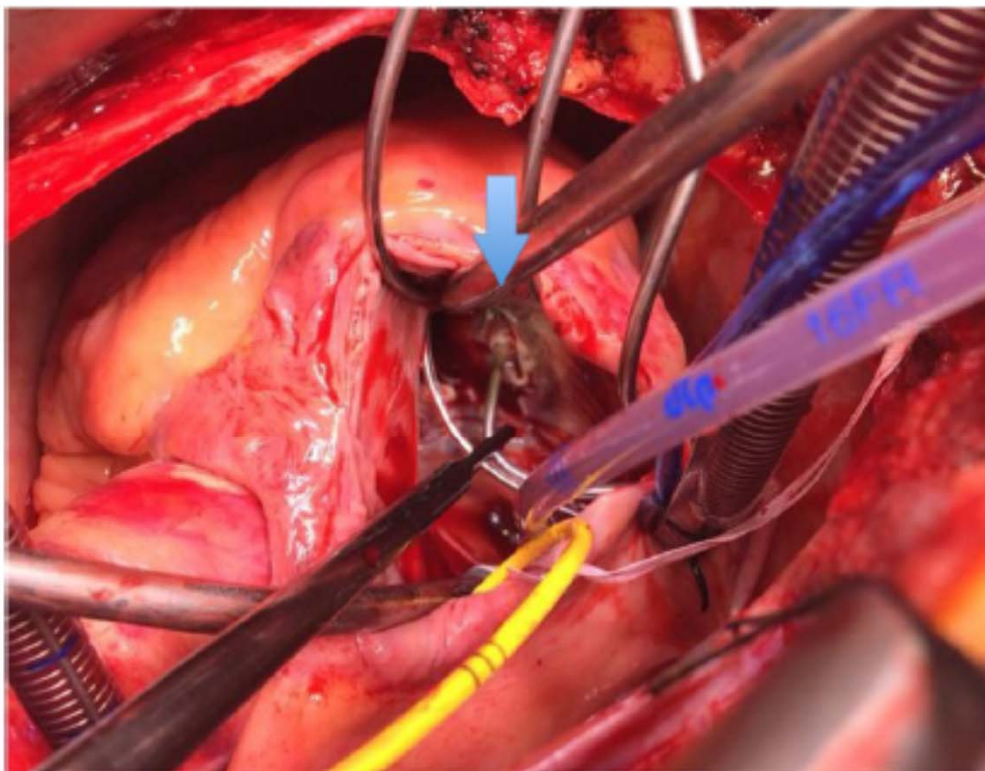
Figure 2 Intraoperative view of the perforating lead. Blue arrow: pacemaker lead perforating the papillary muscle.

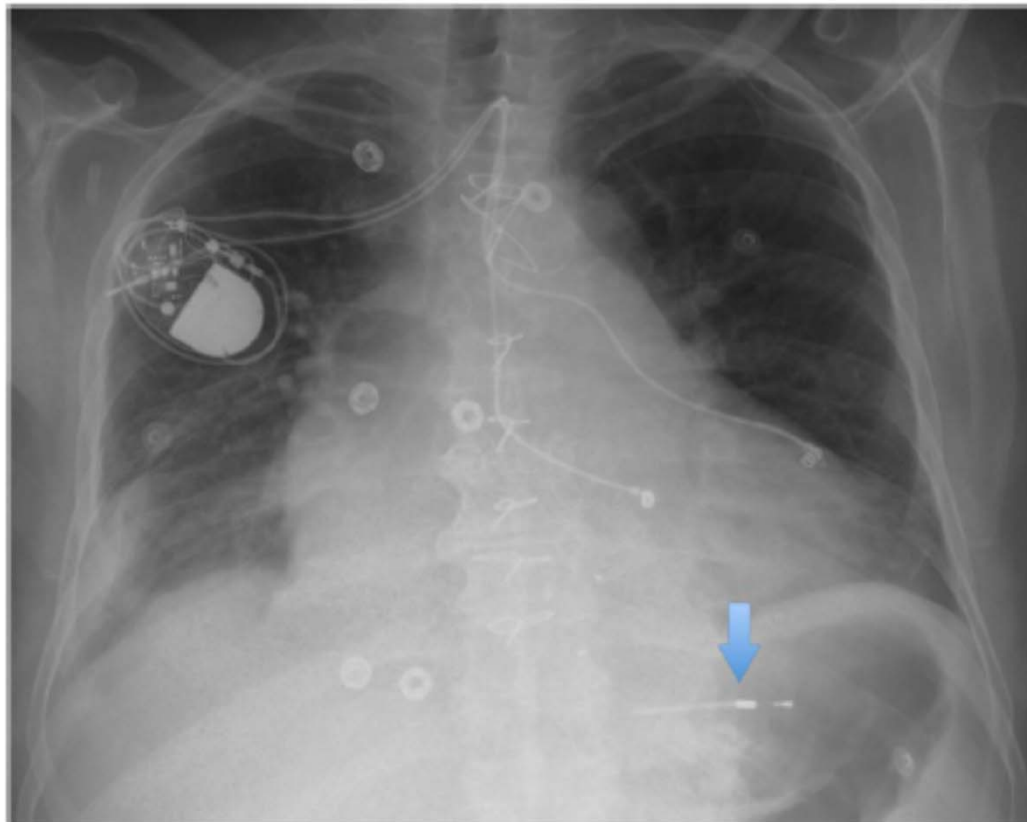
Figure 3 Postoperative chest X-ray. Blue arrow: residual lead fragment.

The valve was replaced with a stented bioprosthesis

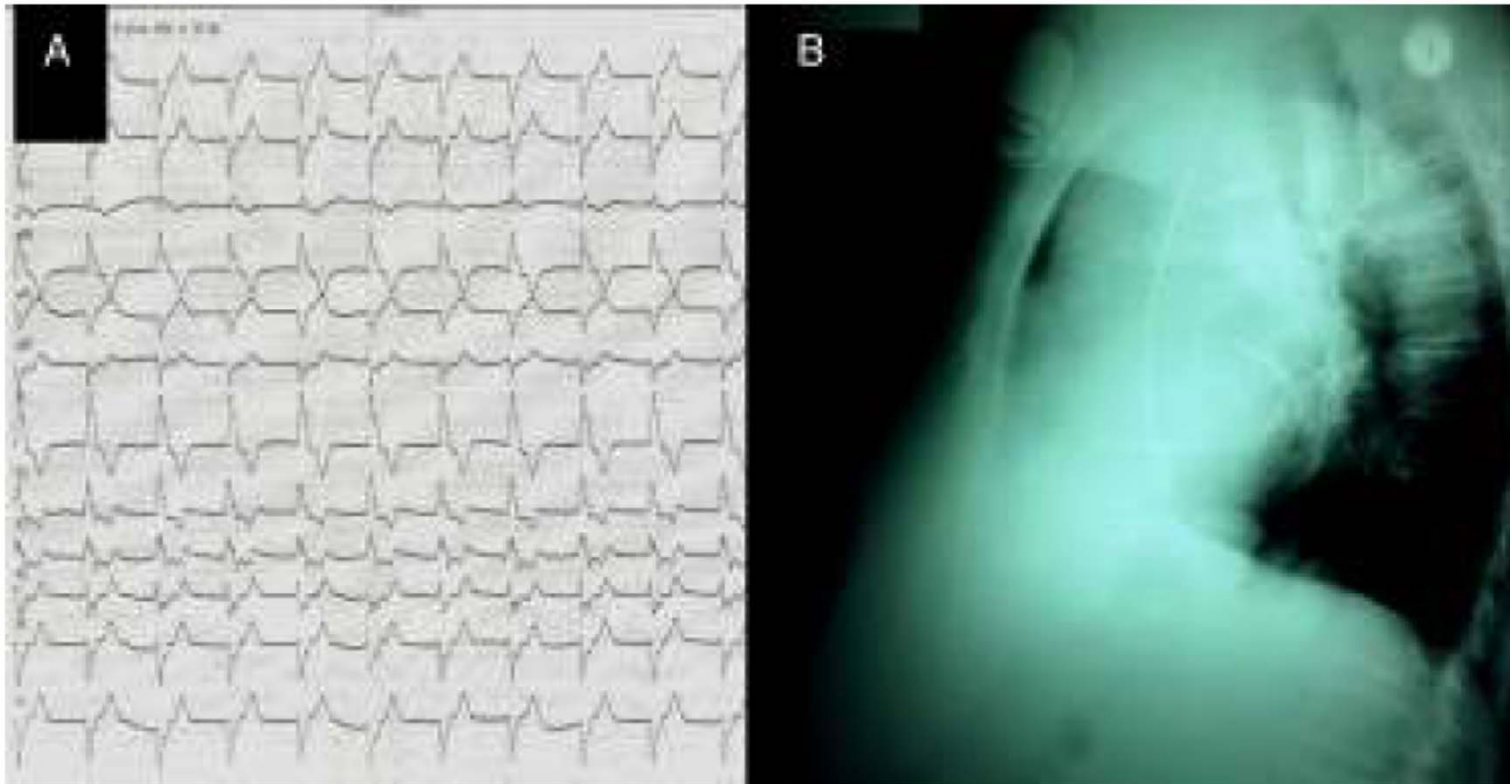
Figure 1 (A) Right bundle branch block pattern of the paced rhythm electrocardiogram; (B) lateral chest radiograph showing posterior orientation of the pacing lead.

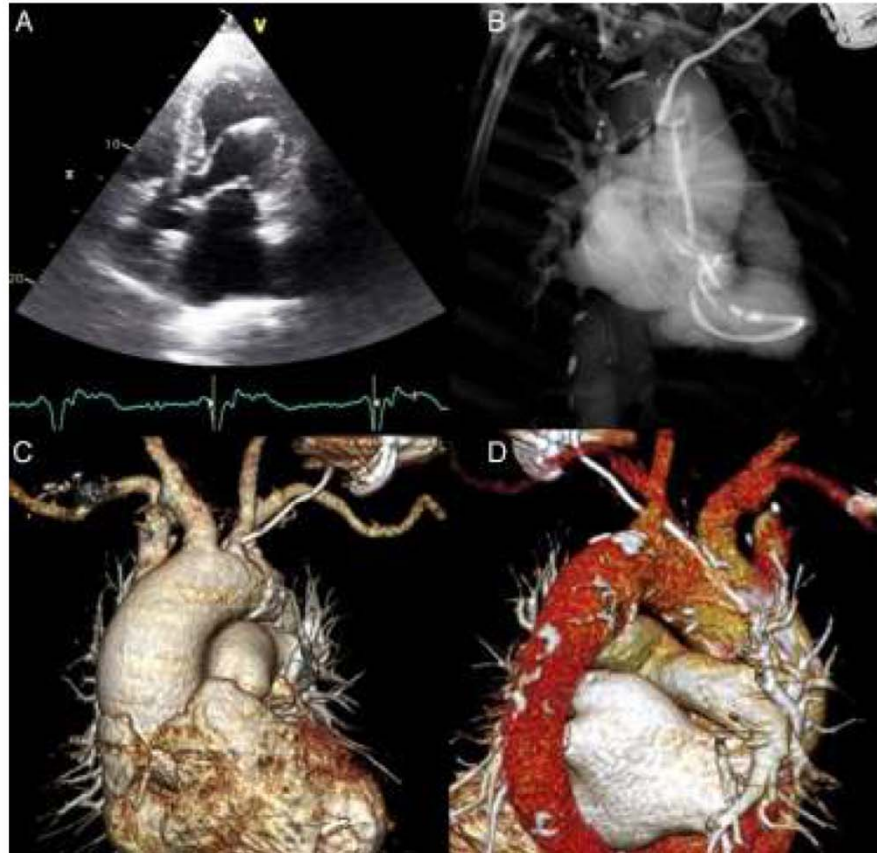
Figure 2 (A) Transthoracic echocardiography, apical 4-chamber view, showing the pacing lead passing through the aortic valve to insert in the left ventricular lateral wall; (B) thoracic computed tomography angiography (CTA), maximum intensity projection image, showing the entire trajectory of the pacing lead through the aneurysmal ascending aorta, aortic valve and left ventricle; (C) volume-rendered thoracic CTA showing pacing lead perforating the atheromatous aortic arch; (D) volume-rendered thoracic CTA showing perforation site between the left common carotid artery and the brachiocephalic trunk.

The patient showed no clinical manifestation of this complication and refused any surgical intervention, including lead removal. She remained on heart failure medication and oral anticoagulation. No clinical or echocardiographic worsening related to the lead's position occurred during 12 months of follow-up. Chronic sensing and pacing parameters remained within normal ranges.
